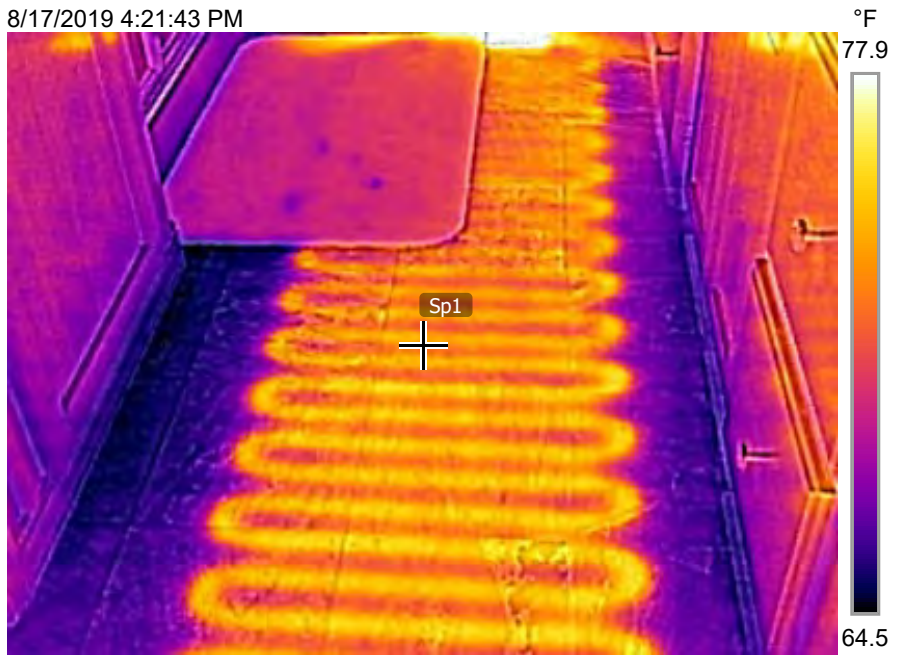
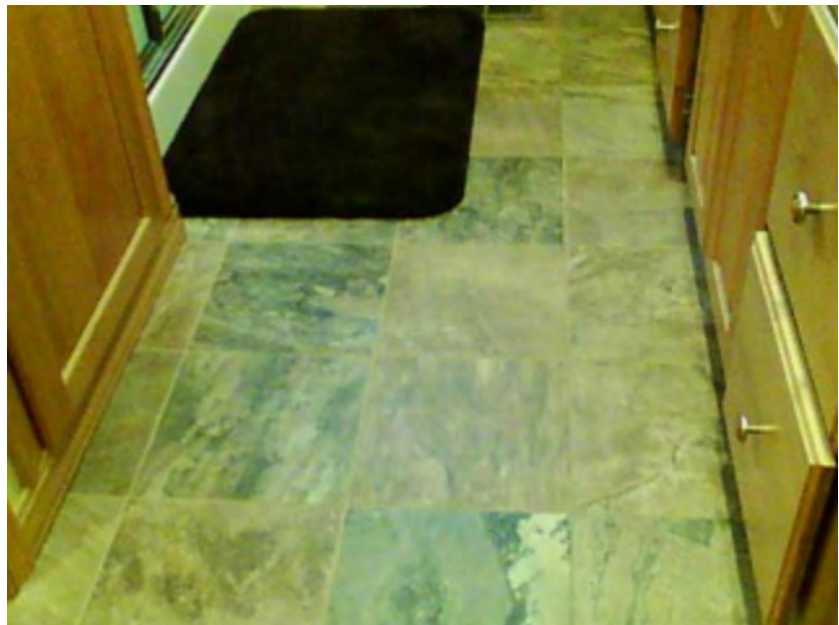
ELECTRIC RADIANT FL... FLIR E8 Wifi 639045830

Sp1	69.7 °F
-----	---------

ELECTRIC RADIANT FLOOR HEATING EASILY SEEN AND FUNCTION VERIFIED

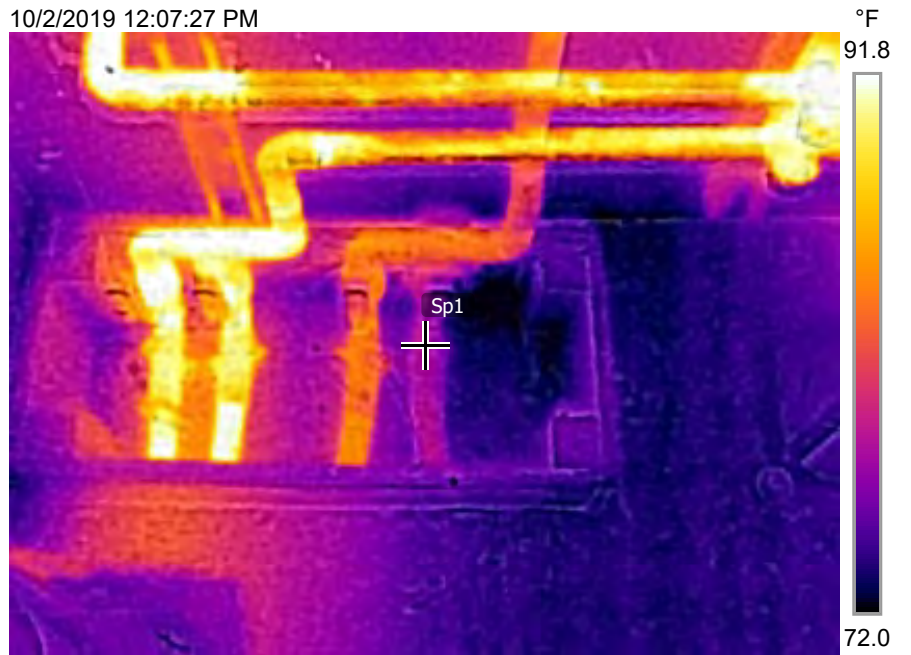
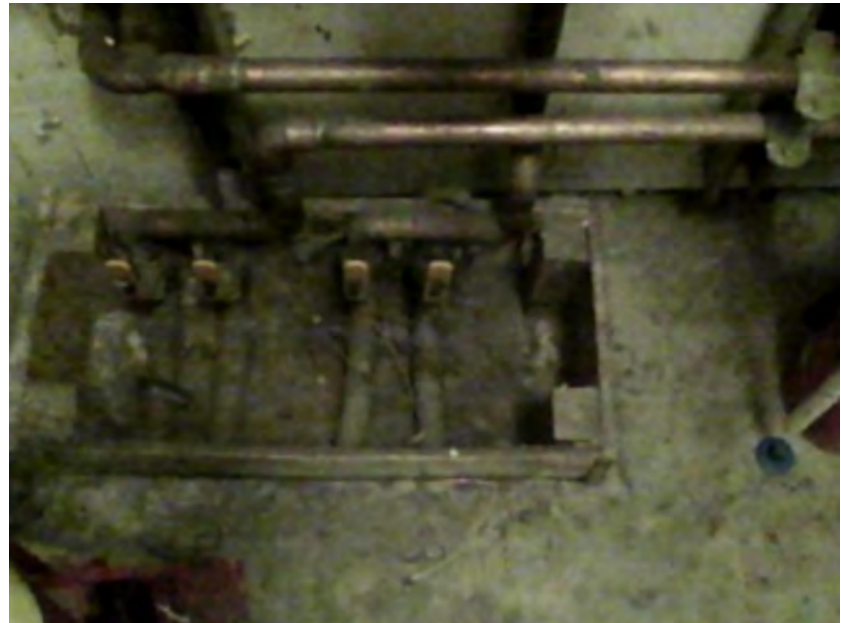
HYDRONIC RADIANT F... FLIR E8 Wifi 639045830

Sp1	75.6 °F
-----	---------

HYDRONIC RADIANT FLOOR HEATING

THERMOSTAT OFF UPON ARRIVAL

THE RIGHT PIPE IS THE RETURN LINE FROM THE LIVING ROOM HEATING ZONE

SYSTEM FUNCTION VERIFIED & IN-FLOOR HEATING LINES LOCATED

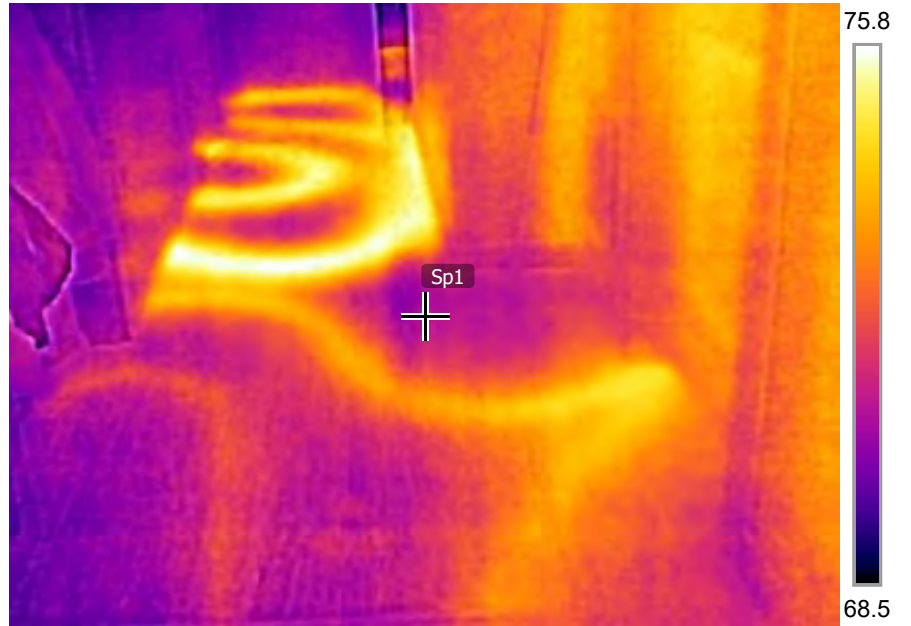
HYDRONIC RADIANT F...

Sp1	71.5 °F
-----	---------

HYDRONIC FLOOR HEATING

THERMOSTAT OFF UPON ARRIVAL

SYSTEM FUNCTION VERIFIED & IN-FLOOR HEATING LINES LOCATED

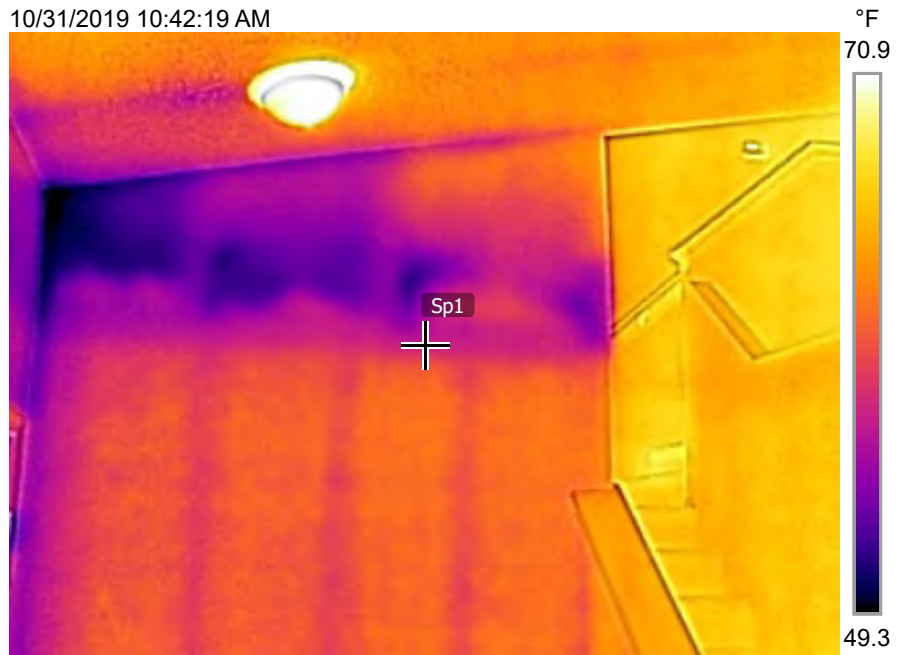
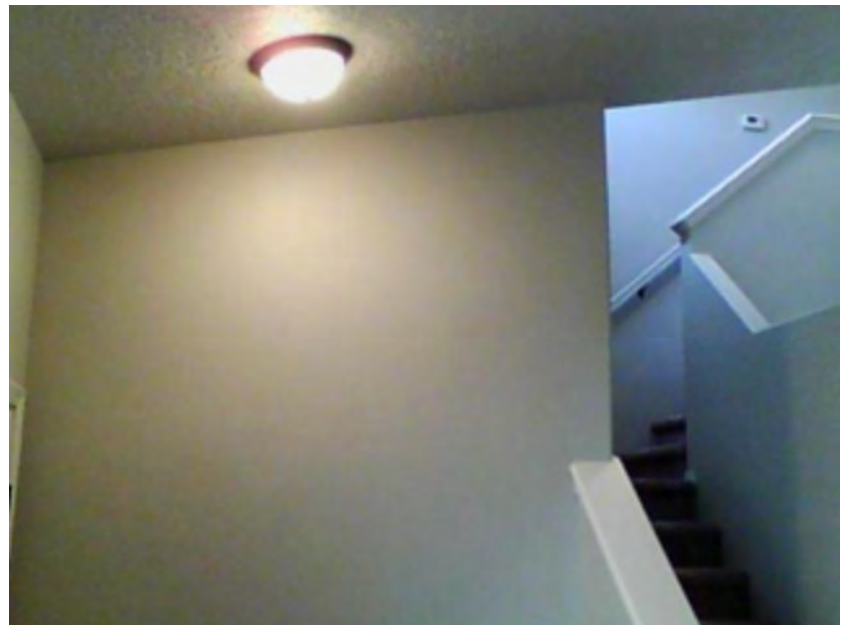
INSULATION PROBLEM...

Sp1	58.6 °F
-----	---------

INSULATION PROBLEM

FIBERGLASS BATTING HAD
FALLEN AWAY FROM THE OTHER
SIDE OF THE WALL

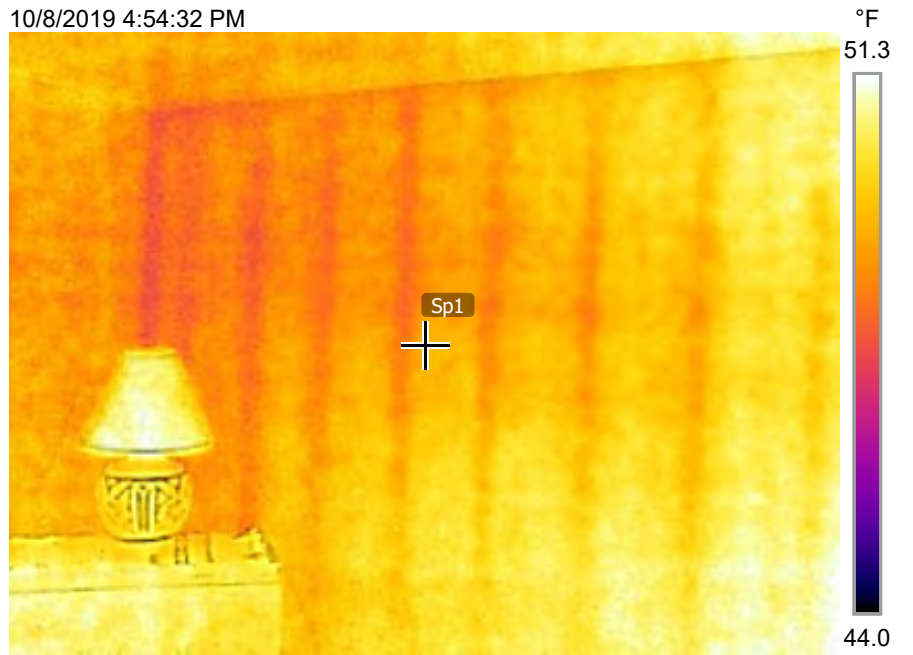
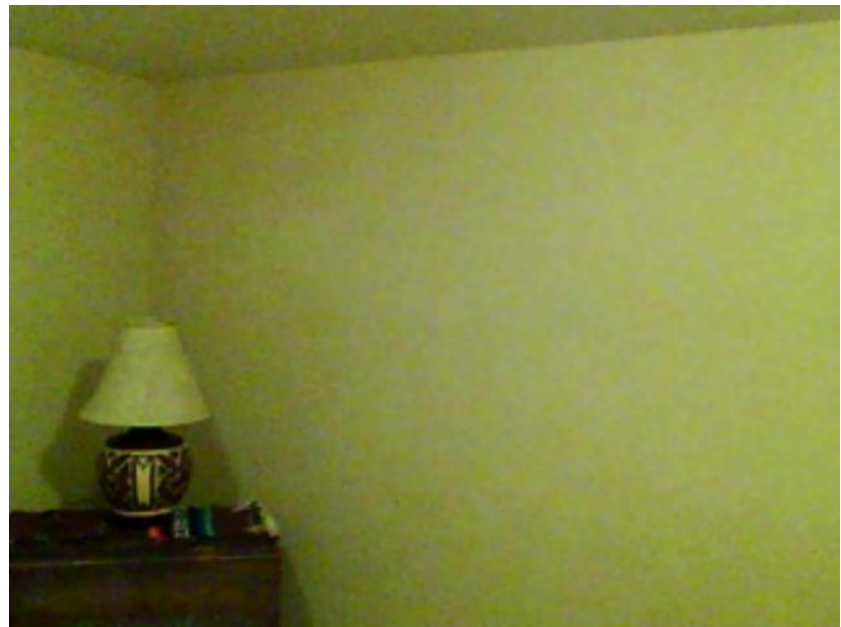
INSULATION GOOD.jpg

Sp1	50.1 °F
-----	---------

NO THERMAL ANOMOLIES - WALL IS WELL INSULATED

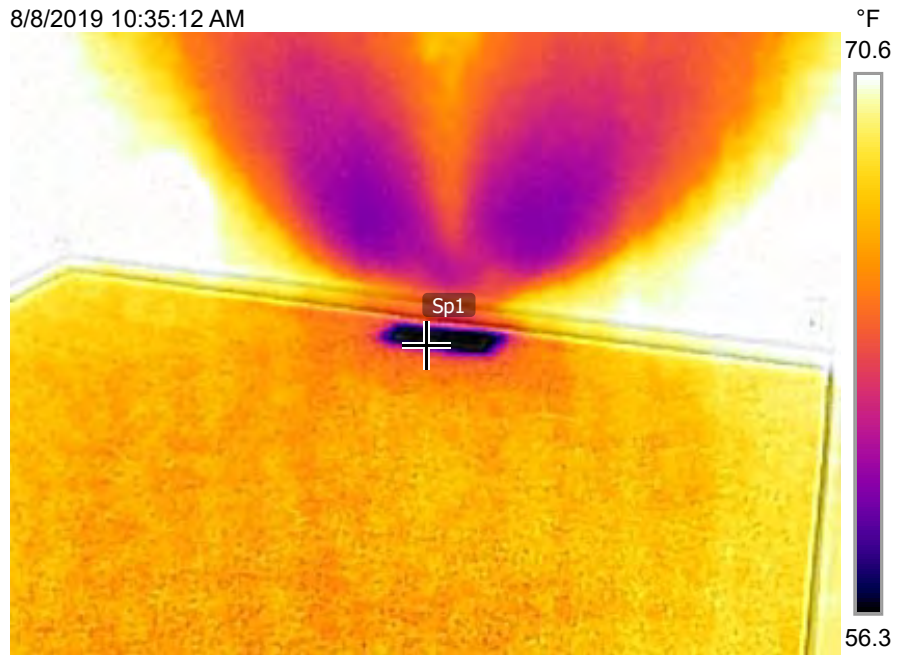
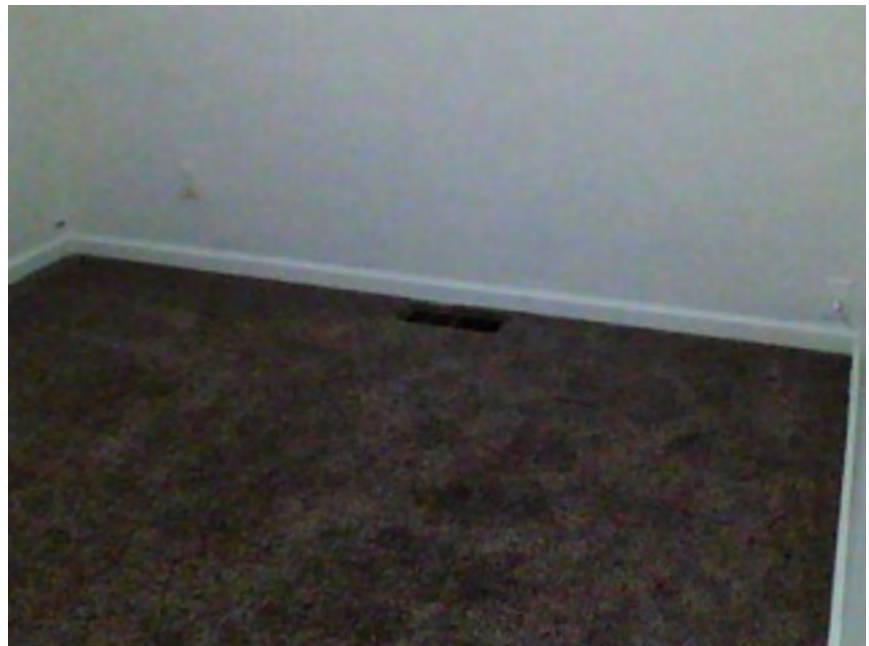
AC & DUCT CHECK.jpg

Sp1	58.9 °F
-----	---------

AIR CONDITIONING

TEMPERATURE & AIR FLOW
VERIFICATION

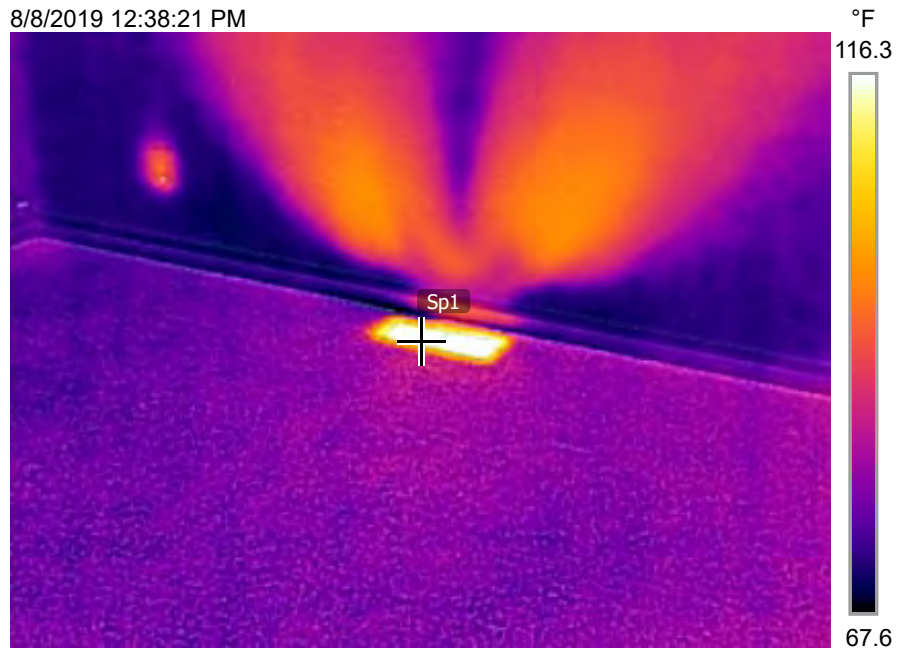
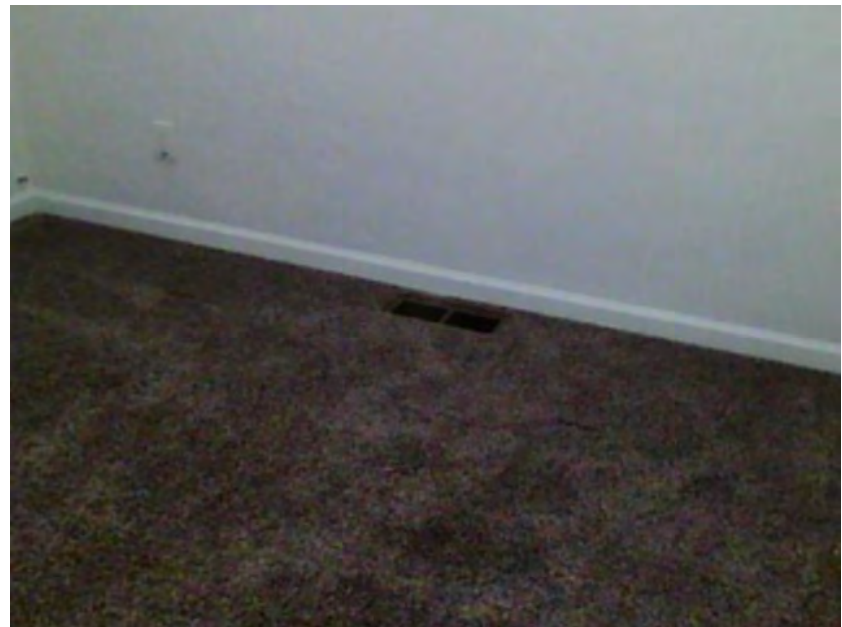
HEAT & DUCT CHECK.jpg

Sp1	123.5 °F
-----	----------

HEATING SYSTEM

TEMPERATURE & AIR FLOW
VERIFICATION

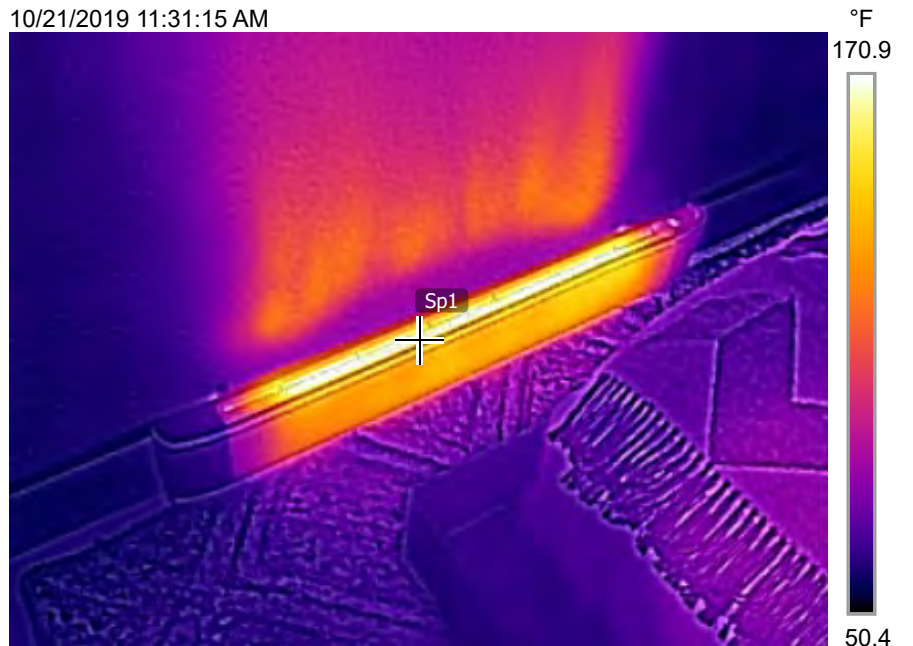
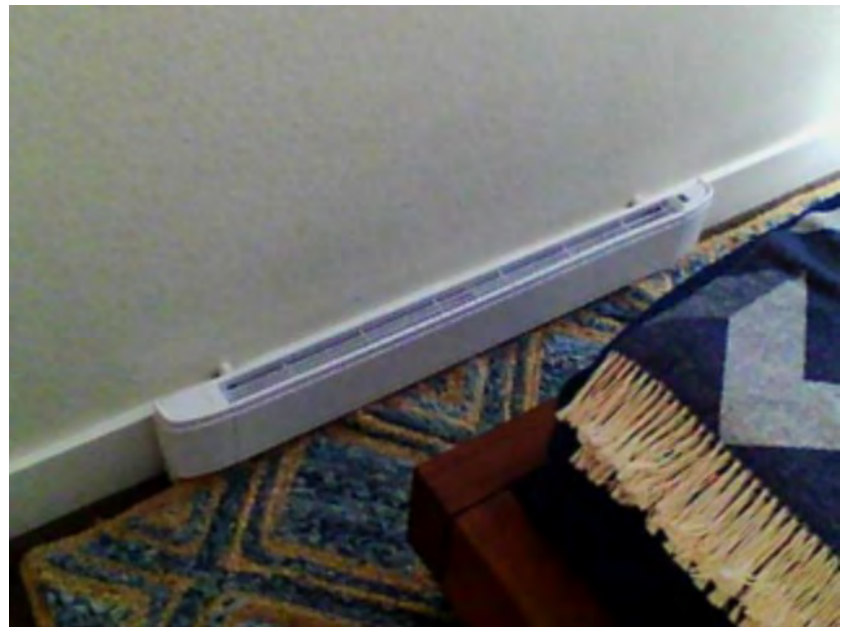
ELECTRIC BASEBOAR...

Sp1	155.0 °F
-----	----------

BASEBOARD HEATING

TEMPERATURE & OPERATION
VERIFICATION
